### CENTRAL INTELLIGENCE AGENCY

S-E-C-R-E-	T		50X1-HU	JM
COUNTRY	East Germany		REPORT			
SUBJECT	Soviet Tank Repair T/54 and PT/76 Ta	r Shop Wuensdorf: nks under Repair	DATE DISTR. NO. PAGES REFERENCES	1 RD		
DATE OF			<u> </u>		50X1-HUI	М
PLACE & DATE ACQ		ATIONS ARE DEFINITIVE. A			50X1-H	IUN
	on the Soviet Tar on the following:	k Repair Shop in Wuen	sdorf which con		report ormation	
	b. T-54 dimension	ons relevant to angle	of glacis and	nose plates	50X1-HUM	
	c. T/54 trials v	with new auxiliary fue	el tank fitting	s.		
	•	fied turret fittings.				
		etch showing the folloose plate angles	owing:			
	b. Auxiliary fu					
		turret fittings			50X1-HUM	
					5	
	[ ] [ ] [ ] [ ] [ ] [ ] [ ] [ ] [ ] [ ]	S-E-C-R-E-	<u>-</u> т	ORR	x	
STATE	ARMY #XNAVY			1 I CIUI

Miscellaneous Information regarding T54 and PT 76
Tanks undergoing repair at the Soviet A.F.V. Repair
Workshops at WUNSDORF

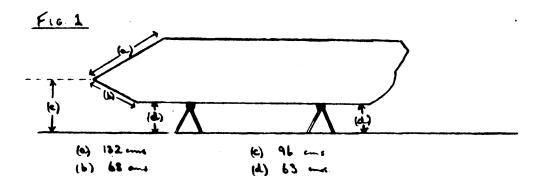
2. A T54 hull undergoing repair in the workshops was mounted so that its belly plate was 63 cms. from the floor. When so mounted the junction of the glacis plate and lower nose plate was 96 cms. from the floor. The glacis plate was 132 cms. in length, and the lower nose plate 68 cms. (See also Appendix "A" Fig. 1).

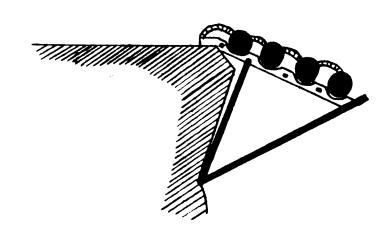
## FIG 2

- 3. In mid-August 1959 trials were currently in progress testing out a fitting at the rear of a T54, to which 4 auxiliary fuel tanks were attached; a side view of this is shown in fig. 2 at Appendix "A". Four auxiliary tanks were carried horizontally on a framework which appeared to be collapsible, or at least capable of folding when not in use. The fuel tanks were each approximately 50 cm. in diameter and their length was equal to the width of the tank hull. They were connected to each other, and the top one to a fitting on the hull, by flexible piping.
- 4. The capacity of each auxiliary fuel tank is 150 litres.
